Errata: CS5378 Rev B Errata

(Reference the CS5378 data sheet revision DS639F2 dated SEP'08.)

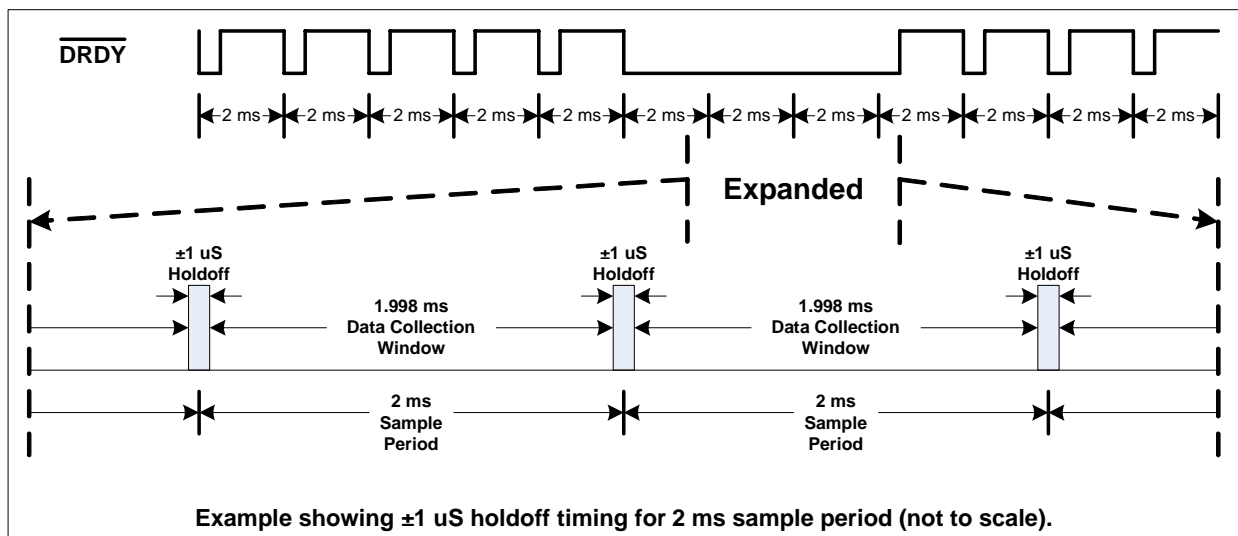
Erratum #1: $\overline{\text{DRDY}}$ Lock Condition

When the CS5378 revB device has data available in the output FIFO it asserts the $\overline{\text{DRDY}}$ pin low to signal the external system to initiate a data collection transaction.

If the external data collection transaction is initiated coincident with a subsequent data word being written into the output FIFO the $\overline{\text{DRDY}}$ signal can permanently lock into a high or low state and no further data transactions can occur.

This erratum is hardware related and requires a hardware reset if it occurs. This behavior can be prevented by always collecting data within one sample period after $\overline{\text{DRDY}}$ goes low so the output FIFO never contains more than one sample.

If the output FIFO must be used due to latency collecting data, carefully time the data collection transaction to avoid an integer sample period timing relative to the initial $\overline{\text{DRDY}}$ assertion. A holdoff of at least ± 1 μs is required around the integer sample period time.

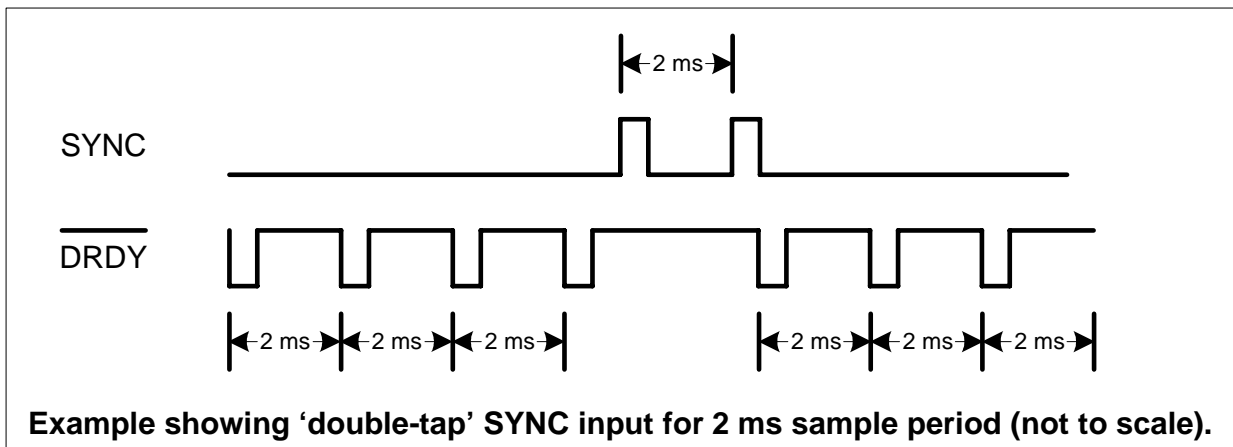
Erratum #2: Early Synchronization Timing

Applying a rising edge to the CS5378 revB SYNC pin synchronizes the external analog sampling and internal digital filter state machine to a hardware generated MSYNC signal. The MSYNC signal timing is within 2 μ s of the incoming SYNC rising edge as shown in the timing diagram on page 16 of the data sheet.

Depending on the specific timing of the SYNC input relative to previous SYNC inputs (or the initialization 'Filter Start' command if SYNC has not been previously applied), it is possible for the digital filter state machine to synchronize 1/8 of a sample period earlier than expected. As an example, for 2 ms sampling, it is possible for the digital filter synchronization to be 250 μ s earlier than expected depending when the SYNC input is received relative to the previous SYNC input.

Because this early synchronization condition only occurs when the SYNC input is received with a specific timing relative to a previous SYNC signal, a 'double-tap' SYNC input will guarantee proper synchronization. The external system should apply the first (asynchronous) SYNC input immediately and then delay exactly one or more integer sample periods and apply a second (synchronous) SYNC input.

Most CS5378 devices in a system receiving an asynchronous SYNC signal will not exhibit this early 1/8 sample period synchronization, so a second synchronous SYNC input will be transparent to normal operation. For the small number of devices in the system that do exhibit this early 1/8 sample period synchronization, the second synchronous SYNC input will correct the timing.
